Contract #: 04-0120F4Cty: SF/ALA Rte: 80 PM: 13.2/13.9File #: 69.28**WELDING INSPECTION REPORT****Resident Engineer:**Pursell, Gary**Address:** 333 Burma Road**City:** Oakland, CA 94607**Report No:** WIR-002864**Date Inspected:** 09-Jun-2008**Project Name:** SAS Superstructure**OSM Arrival Time:** 630**Prime Contractor:** American Bridge/Fluor Enterprises, a JV**OSM Departure Time:** 1530**Contractor:** Zhenhua Port Machinery Company, Ltd (ZPMC), Changxing Island **Location:** Shanghai,China**CWI Name:** C. M. Chen**CWI Present:** Yes No**Inspected CWI report:** Yes No N/A**Rod Oven in Use:** Yes No N/A**Electrode to specification:** Yes No N/A**Weld Procedures Followed:** Yes No N/A**Qualified Welders:** Yes No N/A**Verified Joint Fit-up:** Yes No N/A**Approved Drawings:** Yes No N/A**Approved WPS:** Yes No N/A**Delayed / Cancelled:** Yes No N/A**Bridge No:** 34-0006**Component:** OBG**Summary of Items Observed:**

South Fabrication Bay OBG Assemblies

WELDING INSPECTION REPORT

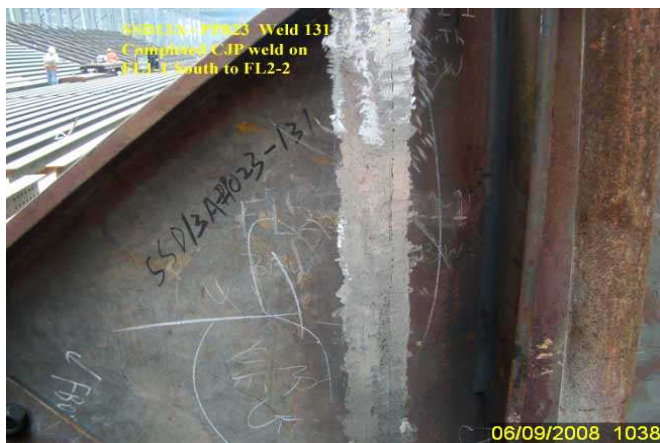
OBG Assembly Segment 3BW- The C5 and E7 side panels have been CJP splice welded to the D6 bottom plate. The Floor Beam has been fit-up and welded at several locations. See Photograph below of Completed CJP weld on FL1-1 south to FL2-2.
